Q9.99 List of known issues

for the development of an STM ATB

Colophon	
Document ID	Q9.99
Version	2.0
Revision	546014
Author	JH
Reviewed	546014 ,STMA-79804
Approved	546014 ,STMA-79811
Archive	
Date:	2020/07/24 09:08

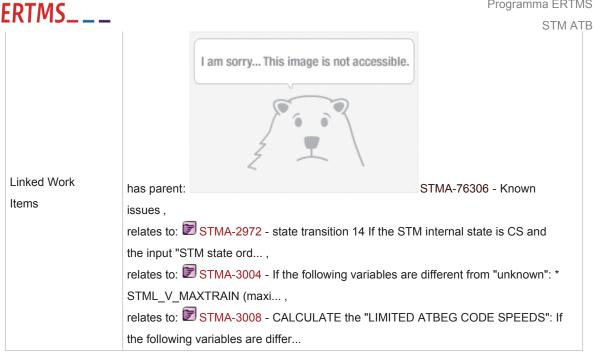
Known Issue, STMA-76536 - Vmax_ATB may be set to "unknown"

If STML_V_MAX_TRAIN is set to "unknown", then Vmax_ATB would be set to "unknown" by STMA-3004, which is not correct because this value is used as a "number" in other requirements. In practise, this situation will never occur. The issue has been partially resolved by rewriting the requirement. However, it could not be implemented in source code anymore.

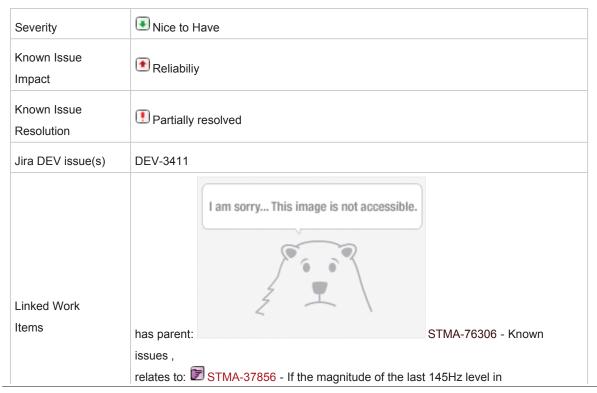
Known Issue, STMA-76546 - Magnitude difference between left and right 145 Hz test signals

STMA-37856 requires that an event flag is set when the magnitudes of the left and right 145 Hz test signals differ more than 20%. The actual implementation (see STMA-37856mCheckConfigurationSignal) implements a check on a magnitude difference of more than 100% - which is stated by DES&IMP to be the correct value.

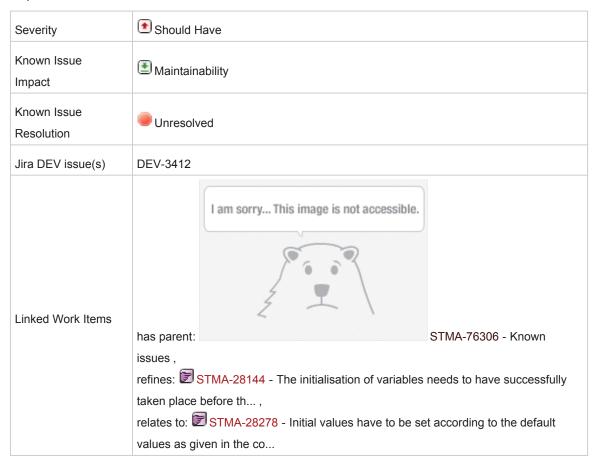
Known Issue, STMA-76564 - Not all source code fragments linked to requirements

Some high-level requirements like for example STMA-28278 in D5.2 have been copied to a limited set of module requirements only - instead of having been copied to all relevant sets of module requirements. This causes a problem that not all source code fragments have been linked to "source" implementation workitems. For example, STMA-28278 describes initialisation of module variables. Each software module has a function for doing thing. However, only the initialisation functions of the FP_HW and IH modules have been linked to the requirement. Therefore, care must be taken when doing code reviews on the source code when "copied in" requirements are used.

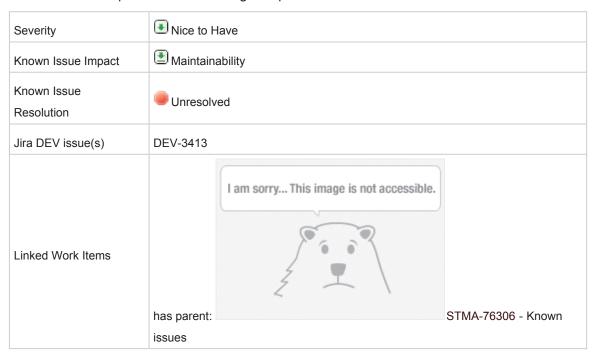
Known Issue, STMA-76568 - STMA-28144 and STMA-28278 can be combined

Requirements STMA-28144 and STMA-28278 overlap. One states that module variables must be initialised before use and the other states that module variables must be initialised to the specified default values. Since this applies to all modules, it would be more efficient to combine these requirements into a single requirement. See also: STMA-76564.

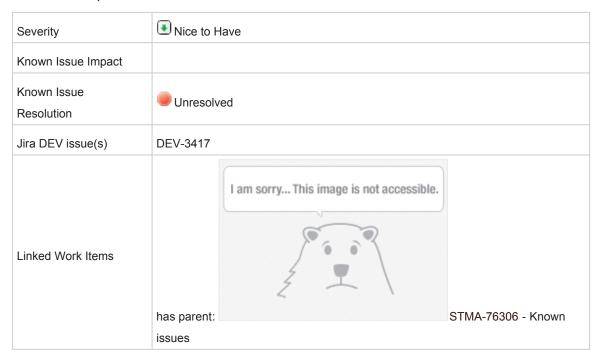
Known Issue, STMA-76748 - STMA-72592 does not test the disconnect reason

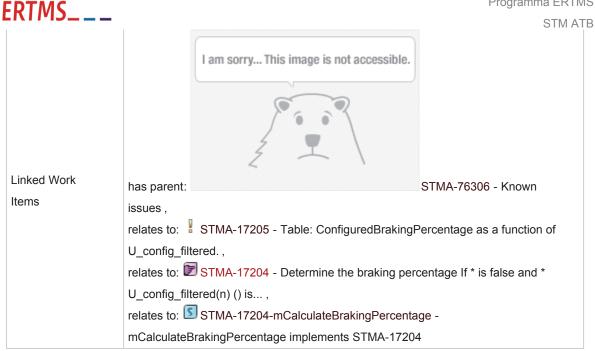
Known Issue, STMA-76754 - Braking percentage table not documented correctly.

The braking percentage table listed in STMA-17205 lists voltage levels in addition to resistance levels. The requirement lists positive-only voltage levels. The table used in the implementation (source code) uses some negative voltage levels as well. The corrected table in spreadsheet format can be found here and in TSTMA-77964 - Configuration resistor:
